Completed Projects - 2011

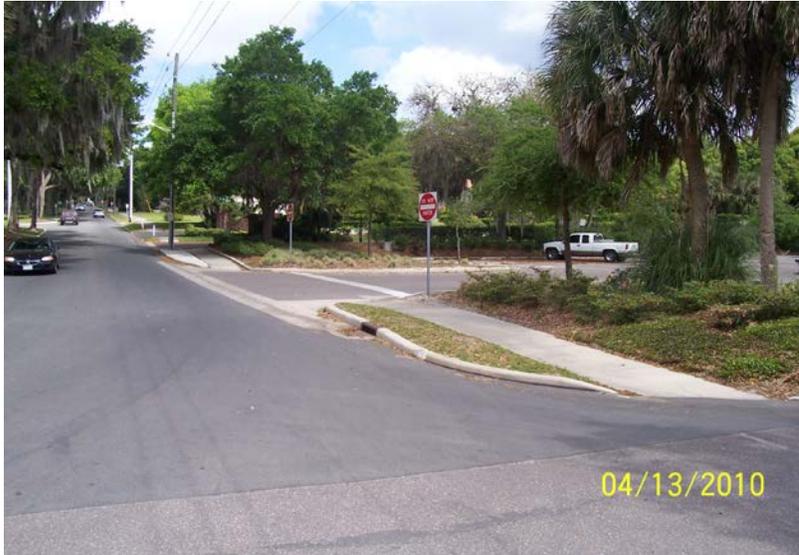
- The stormwater inlet between the entrance and exit of the boat trailer parking lot was set too high to take in the large amount of water flowing down Liberty Avenue.
- The inlet was removed and a new, open throat inlet was installed at a lower level and the street was re-paved to direct water into the inlet.
- This has reduced flooding in that intersection.

Inlet at boat ramp parking lot before modification

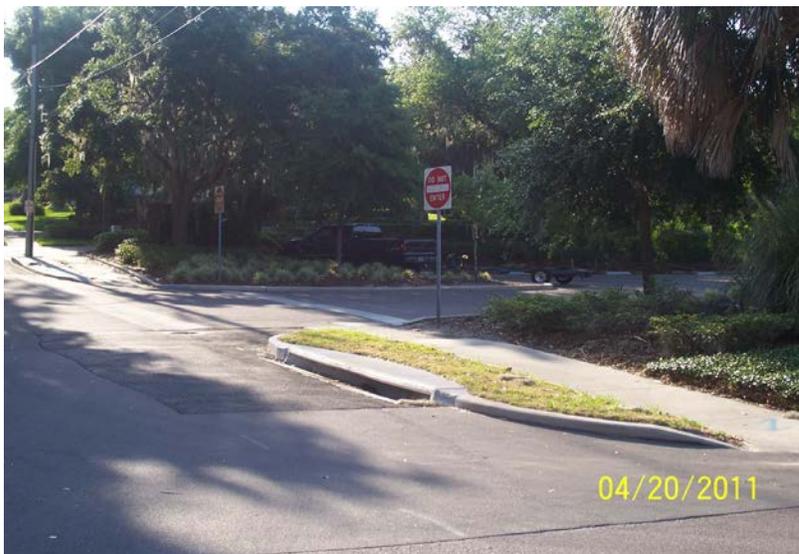
Inlet at boat ramp parking lot after modification

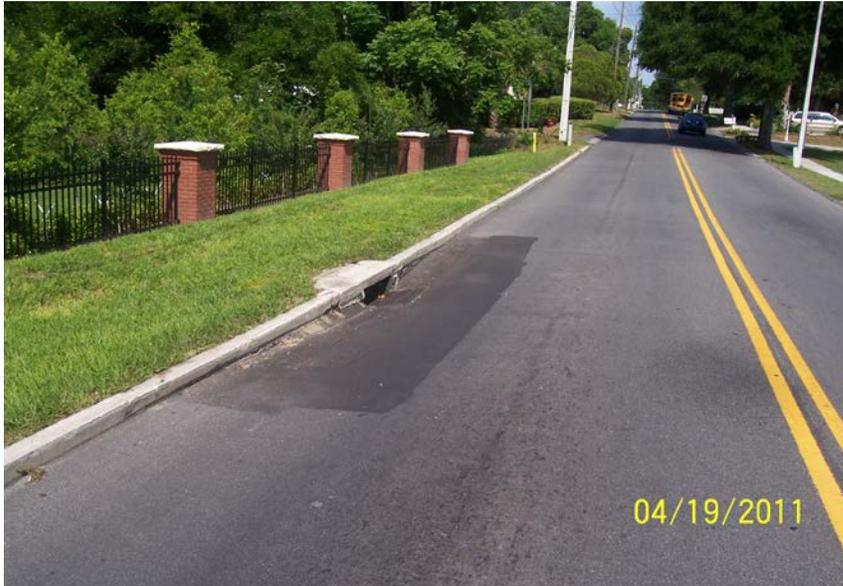
- Fifty stormwater inlets throughout the city had been rendered ineffective by successive layers of pavement building up around them.
- The pavement to both sides of the structures was milled down to below the grate level.
- The areas were re-paved to direct the stormwater runoff into the inlets thereby reducing street flooding.

Milled inlet on 11th Avenue

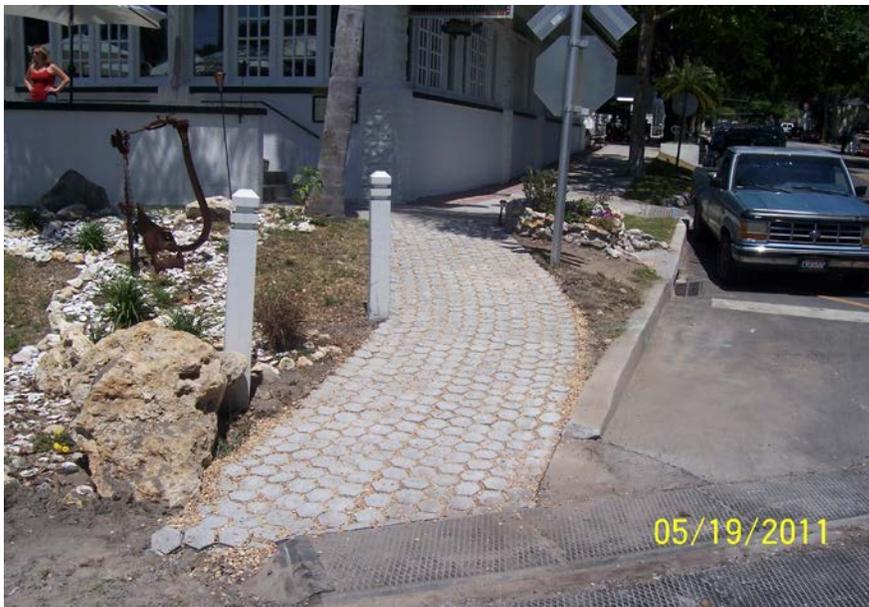
- The area along 4th Ave next to Pisces Rising had been an erosion problem and a pedestrian tripping hazard.
- Working with the staff at Pisces Rising, a new planter box was constructed behind the stormwater inlet to prevent people from walking over the structure.
- A sidewalk was laid down from the existing concrete sidewalk down toward the railroad tracks.
- The new sidewalk was made with Flex-a-path concrete paver rolls. The material conformed to the slope and curve of the sidewalk. Grass seed and pea gravel filled in the joints.
- This was one of the first installations of this product and is used as a demonstration for other installers.

Flex-a-mat sidewalk in front of Pisces Rising

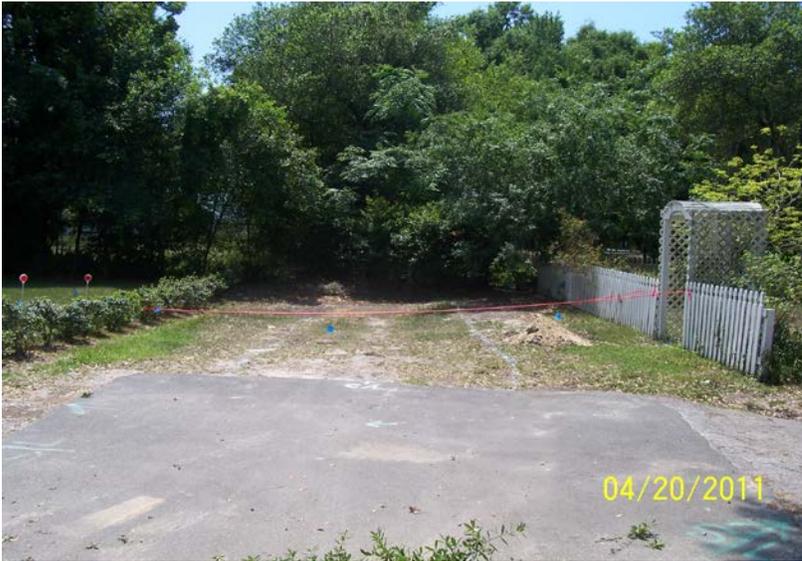
- South Johns Street, off 2nd Avenue, had a history of flooding and erosion problems. Various solutions had been implemented in the past but residents still had stormwater problems during heavy rain events.
- Modifications were made to the drainage on adjoining properties to reduce the amount of runoff contributing to the problems.
- A StormTech underground storage system was installed at the south end of the street.
- The street was re graded to direct the water down the center of the road and into the inlet grate.
- Driveway approaches were raised to keep the stormwater from flooding the residences.

Retention area before re-grading

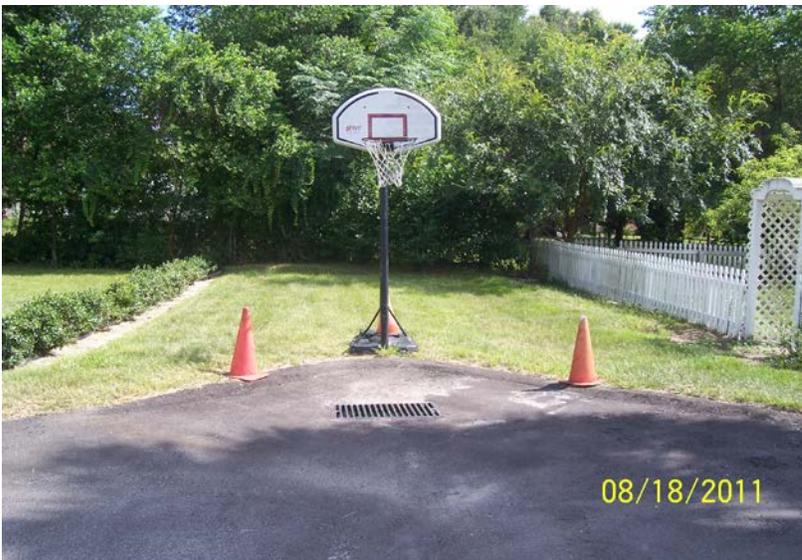
Grate and retention area after paving

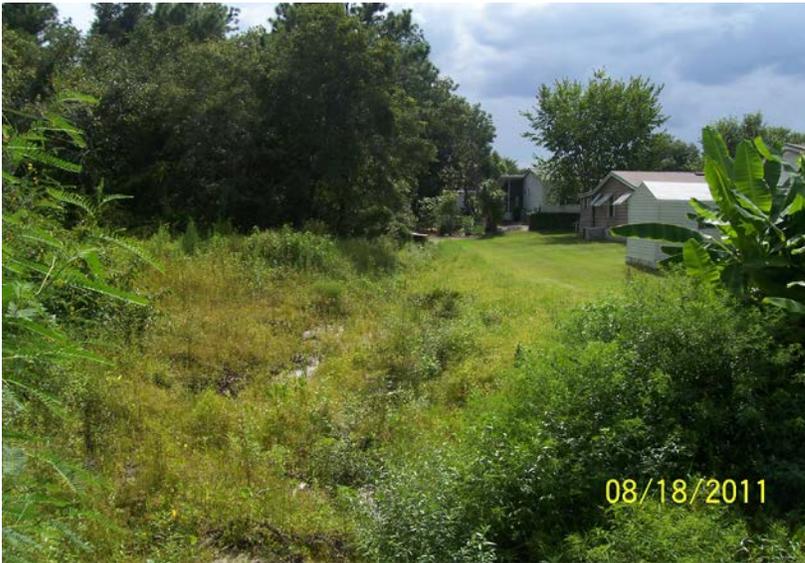
- The tributary of Wolf Branch Creek that flows from US Hwy 441 east through the Dora Pines Development had become filled by sediment
- . The reaches west of Sunrise Blvd and east between Sunrise Blvd and Croat Street had lost most of the capacity to move stormwater runoff through them.
- In a cooperative project with Lake County Public Work the stream was dredged to its original depth and configuration.
- In addition, two rusted metal culverts under Croat Street were replaced by one 48-inch diameter pipe and a retaining wall was installed to prevent erosion off the roadway.

Ditch after dredging and vegetation re-growth

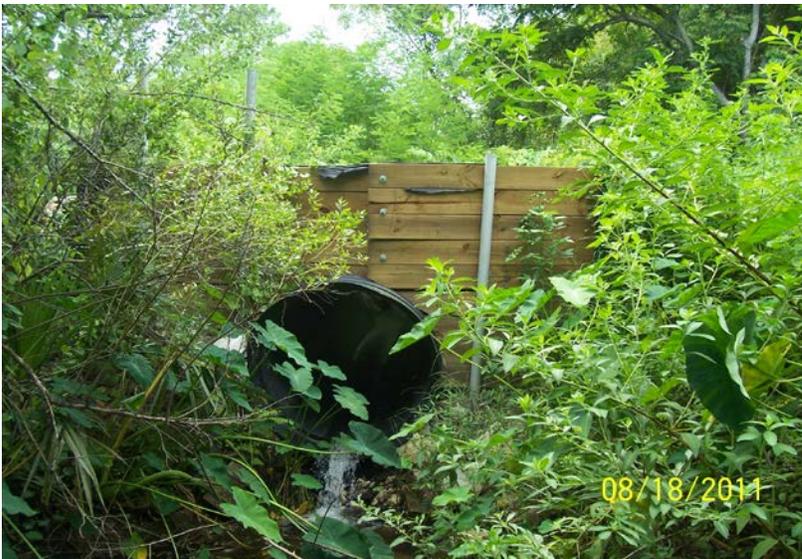
Croat Street culvert and retaining wall

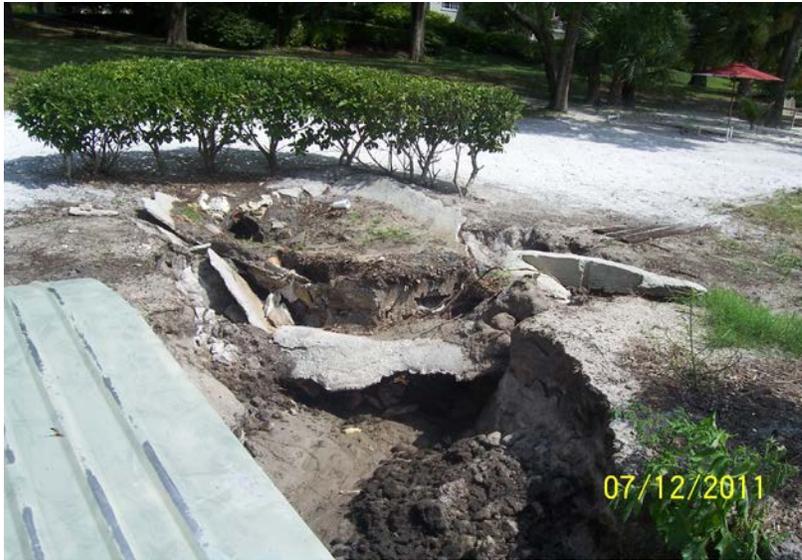
- The stormwater pipe that drains the area of Pine Way and Sylvan Drive had become rusted and the flume at the discharge point into Lake Gertrude was severely eroded.
- The old concrete was removed and a new flexible erosion mat was laid down to prevent further beach erosion.
- The pipe was re-lined using fusible HDPE pipe to prevent future root intrusion which would block the water flow.

Concrete and beach erosion around discharge of pipe

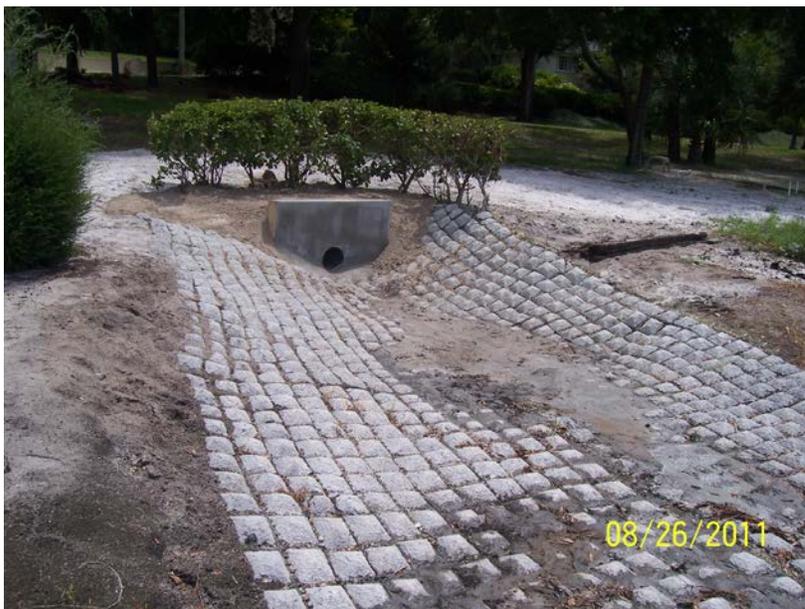
Erosion control mat and concrete headwall

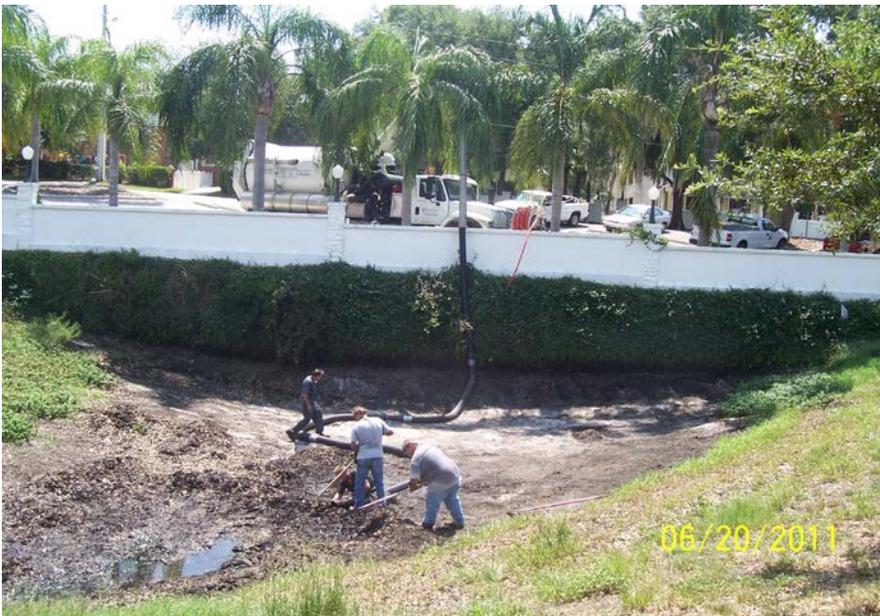
- The retention pond at 5th Ave. and McDonald St. does an excellent job of capturing the leaves, sand and debris that is washed off the city streets during rain events.
- Periodically the accumulated material needs to be cleaned out so that the water can filter into the ground after each rain event.
- Rather than use mechanical means such as a back-hoe or a Bobcat loader that tear up the slope of the pond, the stormwater crew tried a new method.
- Using the large vacuum truck parked in the parking lot above the pond, we extended a long flexible pipe into the pond.
- The leaves and sand were raked into the pipe then were sucked up into the truck.
- This method removed all the materials down to the white sand at the bottom of the pond without damaging the banks of the pond as a loader would have done.
- A total of 25 cu yd of materials were removed using this method.

Vac truck used for cleaning retention pond

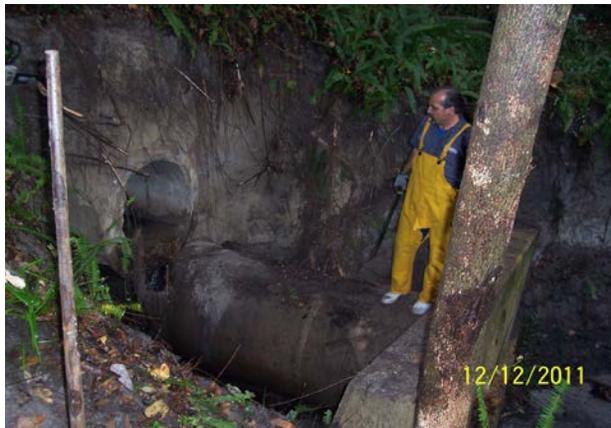
- The stormwater pipe that runs under Donnelly St. directly in front of the Mt Dora Fire & Police Department had broken away from the headwall.
- Water was undermining the ground from the west side of Donnelly St. and eroding the hillside and creek bed.

Broken Pipe and Headwall Settled 5 ft Down

- The situation required immediate attention.
- After discussions with the adjoining landowners, it was decided to install a drop structure and extend the pipe 140 ft further down the valley.

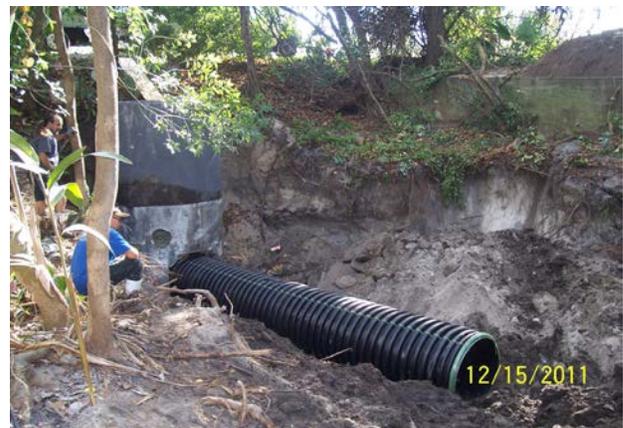
Drop structure with first section of HDPE pipe

- The valley was cleared of trees that had fallen into the gully.
- The existing headwall was removed and a 17 ft tall drop structure was installed allowing the water to step down 5 ft before exiting the structure.

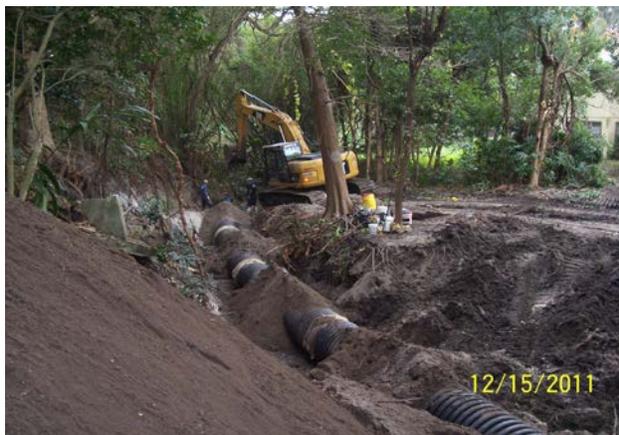
HDPE pipe line running down valley

- One hundred and forty feet of HDPE pipe were installed and a new headwall closed off the downstream end.
- The valley was filled with dirt to establish an even slope from the higher south side down to the lower north side.

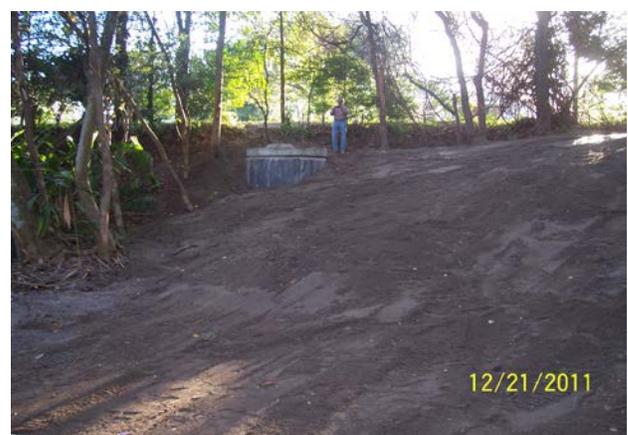
Valley filled in with even slope

- The area was re-seeded using hydro-seeding with a variety of grasses in the blend.
