Completed Projects: 2009

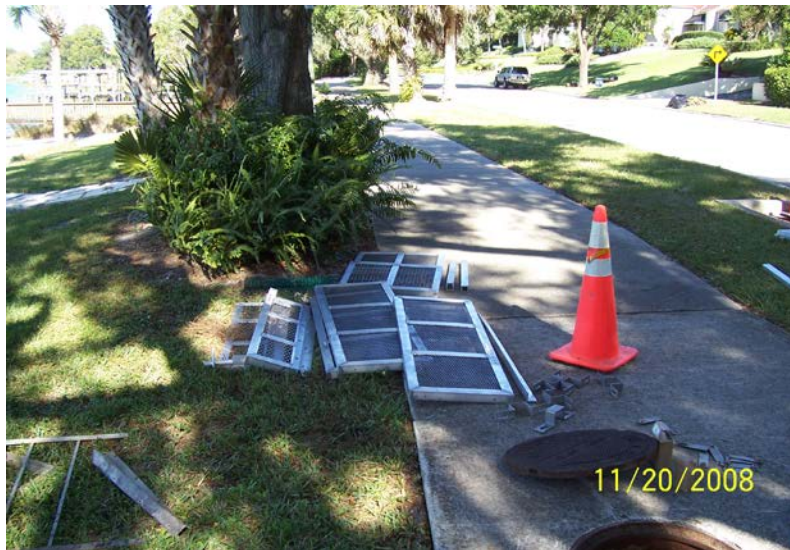
- The installation project that went by with the least amount of notice was installing a Nutrient Separating Baffle Box under the sidewalk on Sylvan Drive next to Lake Gertrude.
- In a previous project a concrete box had been installed under the sidewalk to act as a baffle box. However it did not function efficiently and much of the material captured simply got washed into the lake at the next rain event.
- Using a great deal of ingenuity, the designers were able to create all the parts of the separating baffles and basket to fit down through the manhole. On site the parts were assembled inside the existing box and function as though they were part of a regular treatment unit.
- Although it is smaller than the other units that have been installed, it still collects leaves and sand like its bigger cousins.

Parts of the NSBB Installed Under Sidewalk at Lake Gertrude

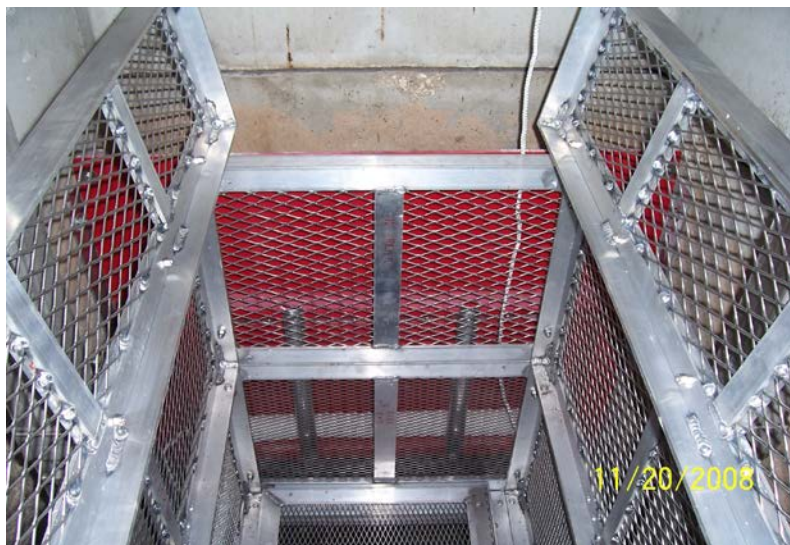
NSBB Installed Inside Existing Box Under Sidewalk

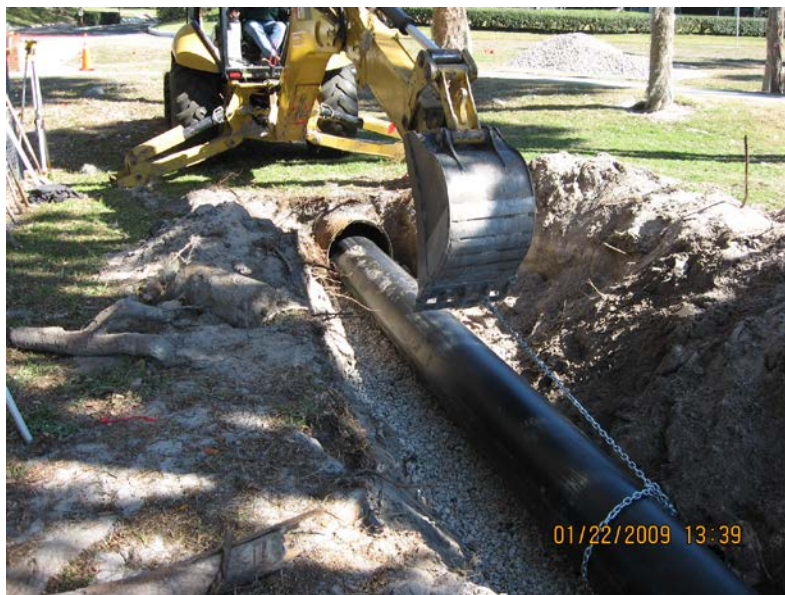
- An old metal stormwater pipe that runs under the north end of park had rusted and collapsed creating a hazardous situation.
- Half of the pipe was removed.
- Then a process known as “Slip Lining” was used to insert a smaller diameter pipe into the remaining pipe up to the manhole. The pipe continued out into the lake.
- Once inserted the gap between the old and new pipes was filled with concrete to seal it.
- The new pipe is a heavy HDPE material that will not decompose and has no joints or gaps for tree roots to grow through and clog the drain.
- The pipe was buried and the area landscaped.

Slip-Lining a New Pipe at Gilbert Park by Marina

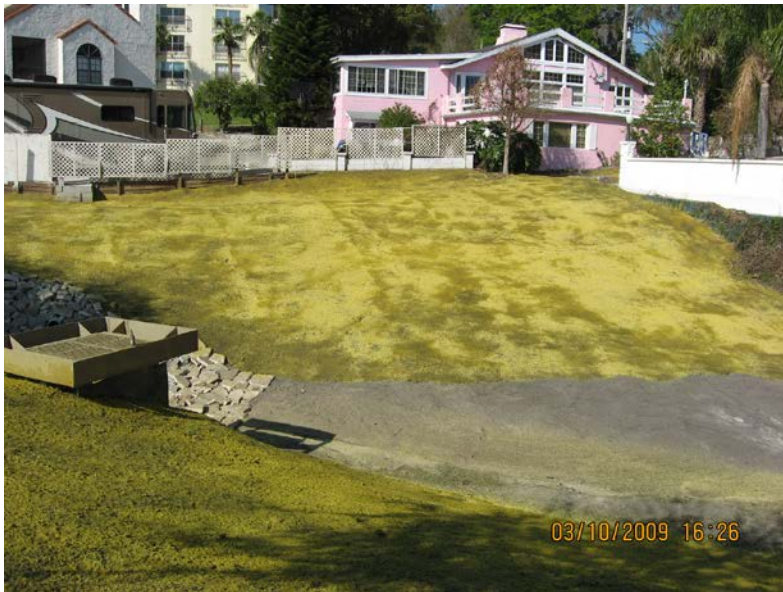
- The pond was excavated down to its original depth removing the years of accumulated leaves and sediment that was preventing the water from infiltrating into the ground as it as designed to do.

Retention Pond at Old 441 Repaired and Hydroseeded

- The fence along the north side of the pond was cleared of old brush that had grown over it.
- A new drain was installed from the driveways of the properties north of the pond down to the bottom of the pond. This will prevent the erosion of the pond banks that was a constant problem in the past.

- Once completed the site was seeded using a process known as “Hydro-Seeding” which sprays a mix of several grass seed types, fertilizer and an emollient that holds it all together until the grass can become established and hold the soil in place.

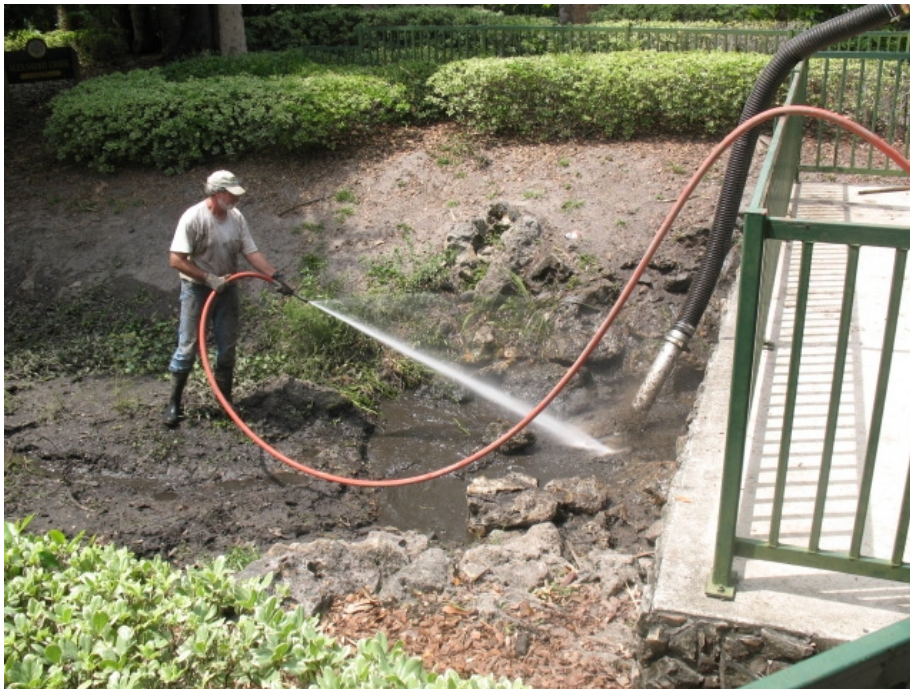
- The upper pond of Alexander Creek in Gilbert Park has become filled in with sediment and debris. Woody plants had begun to choke out the pond and make it unsightly.
- Using the City's Vac Truck, the sediment was removed from the pond. The rocks were washed free of sand and dirt that had covered them.
- Now the pond will function as a sediment trap as it was originally designed. This process will need to be repeated every few years to maintain the look of the pond and to allow it to continue to trap sediments that would otherwise flow into Lake Dora.
- Two steel manhole covers were replaced with fiberglass grates to allow surface runoff to flow into the storm drain reducing the erosion caused by the water running down the slope on the north side of the playground.

Jet and Dredging of Alexander Creek Upper Pond

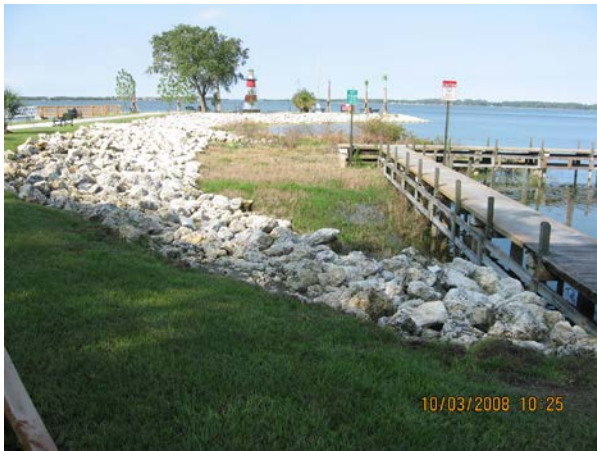
- The dock on the south side of the boat ramp had become completely landlocked.
- A dredging project was undertaken to remove the years of accumulated sediment from the lake and the make the dock usable by boaters again.

Lighthouse Point & Dock Before Dredging

- The wooden approach section of the dock was removed to allow a loader with a 60 foot boom to access the area. Working from the open water toward shore the operator dug out over 1800 cubic yards of material from the lake.

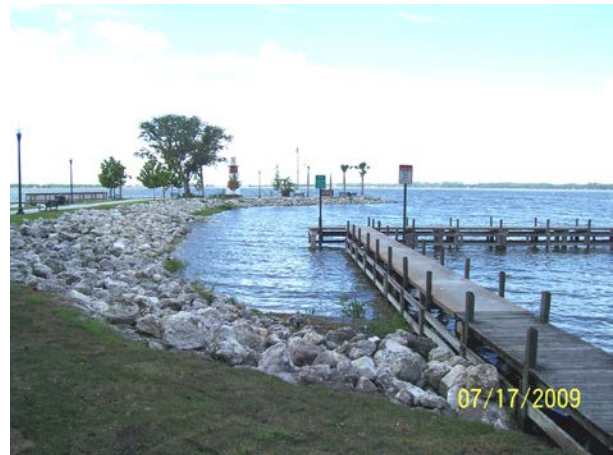
Lighthouse Point & Dock After Dredging

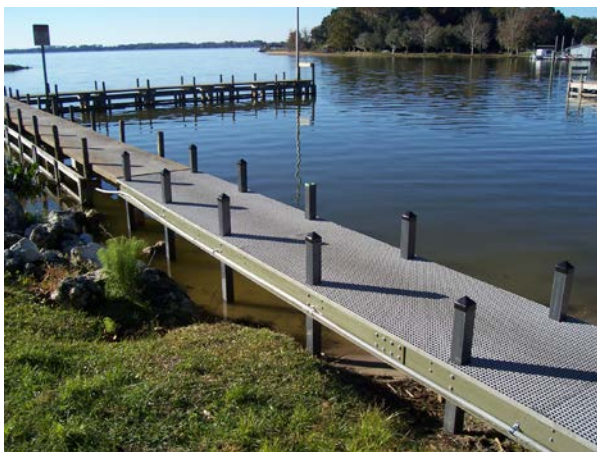
New Dock Approach at Boat Ramp

- Once the dredging was completed the dock was re-built using fiberglass posts and composite material decking which will last for many years without the need for maintenance.
