Completed Projects: 2009

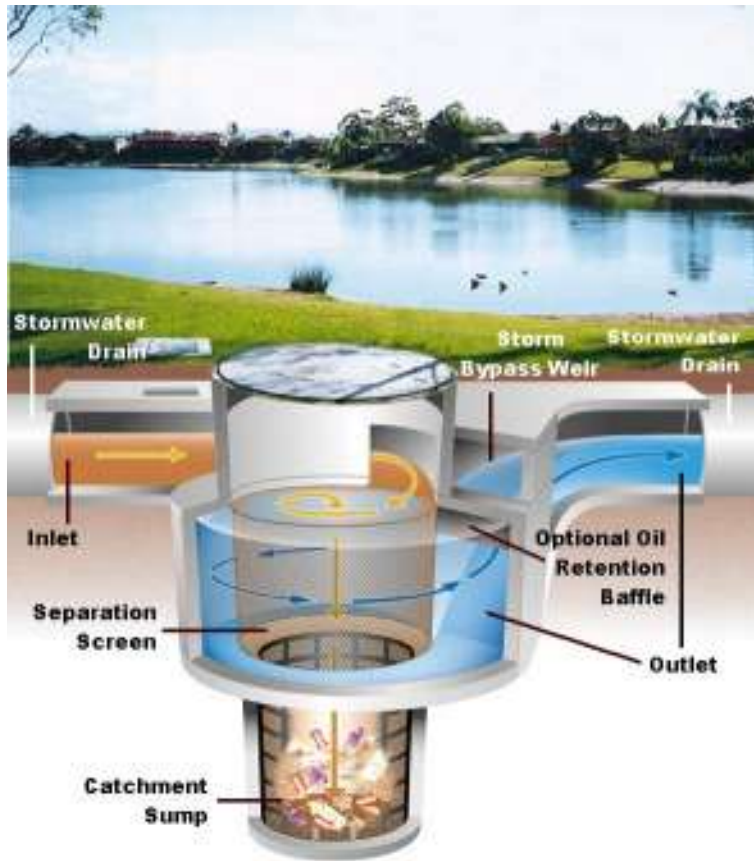
Lake Dora Dr (Boathouse Rd) Stormwater Treatment Unit Repair:

- A Continuous Deflective Separation (CDS) unit was installed under Lake Dora Drive to remove any sediment from the water discharging into Lake Dora.
- The unit uses the water's own power to spin it through a mesh that removes the heavier sediment particles which fall into a sump in the bottom of the unit.
- The unit was backing up during heavy rain events and pushing the covers off the manholes. A panel inside had broken preventing water from leaving the unit as designed and forcing it up through the street.
- The broken panel was removed and the entire unit cleaned.

Graphic of Continuous Deflective Separation Unit
