Completed Projects – 2010

4th Avenue Stormwater Project:

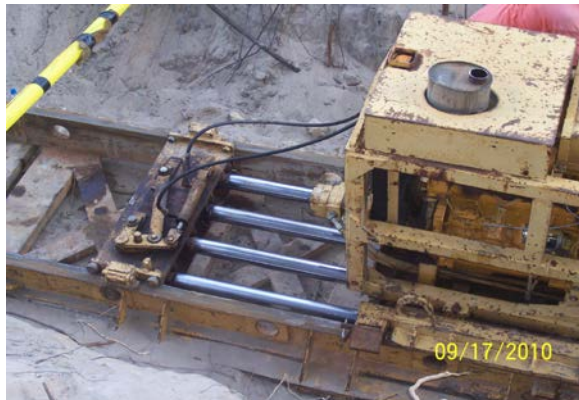
Hydraulic rams for Jack & Bore

- The existing stormwater pipe system under Fourth Avenue between McDonald and Donnelly Streets did not have the capacity to carry the amount of water necessary to prevent flooding.
- A new line was installed along the length of the road.
- A portion of the pipe line went under the CF Rail Road tracks by Pisces Rising using a technique called “Jack & Bore”.
- New sanitary sewer lines and structures were installed at 4th Ave & McDonald St while the intersection was open for the stormwater project.
- At the corner of Donnelly Street and Fourth Avenue, two new stormwater inlets were constructed and a Nutrient Separating Baffle Box was installed under Fourth Avenue.
- This will help to remove the sand and debris that is washed from the streets before it reaches Lake Dora.
- This project was partially funded by the Lake County Water Authority.

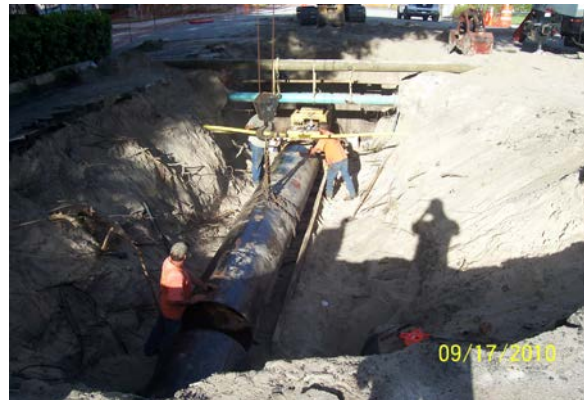
Steel casing with auger being set in place

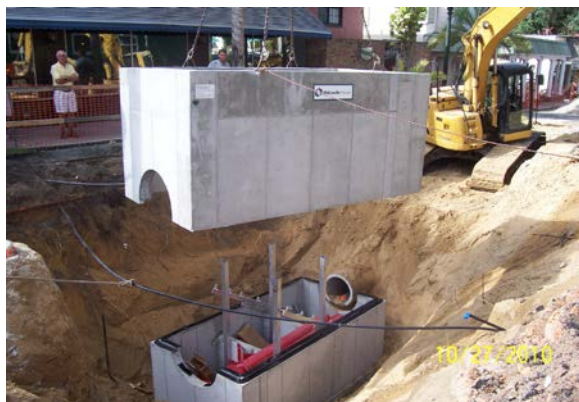
Top section of baffle box being set in place

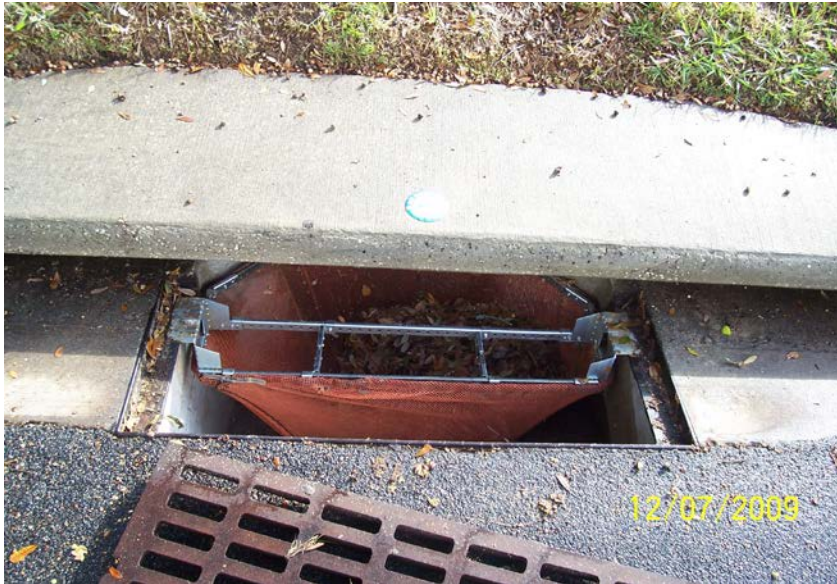
Flexstorm inlet filter at 6th Avenue and McDonald Street

- Thirty five stormwater inlets in the downtown area were installed with Flexstorm Inlet Filter Baskets.
- These baskets are installed under the metal grates to capture the leaves and debris that is washed off the streets.
- The organic material captured is held in the basket and dried out in between rains, which prevents it from decomposing and being washed into the lake at the next rain event.
- This project was partially funded by the Lake County Water Authority.

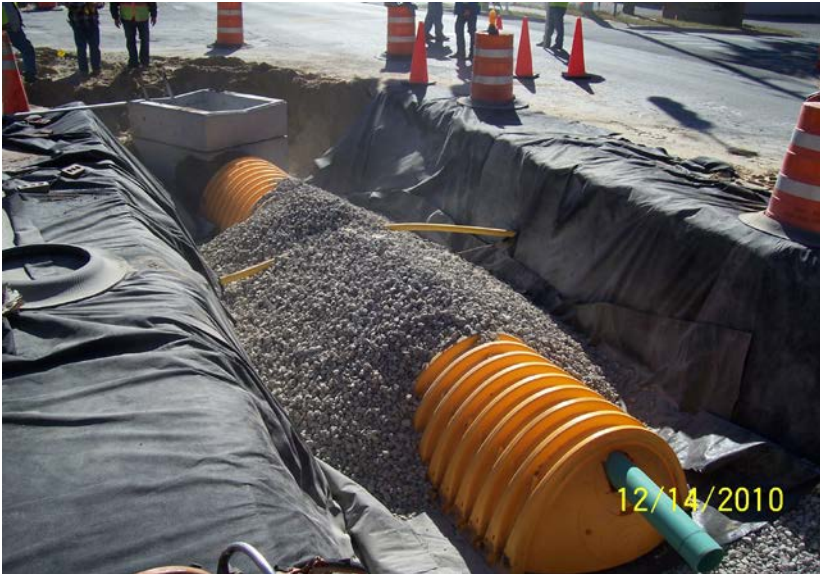
StormTech Chambers with filter fabric wrap and stone

- During the reconstruction of the intersection at Highland St. and 1st Ave., a StormTech underground stormwater storage and exfiltration system was installed.
- It is designed to capture stormwater runoff from Highland Street and store it underground in the large yellow chambers and surrounding stones. The water filters into the ground after the rain event.
- The system was designed with three sections for ease of maintenance in the future.
- This was a cooperative project with Lake County Public Works.

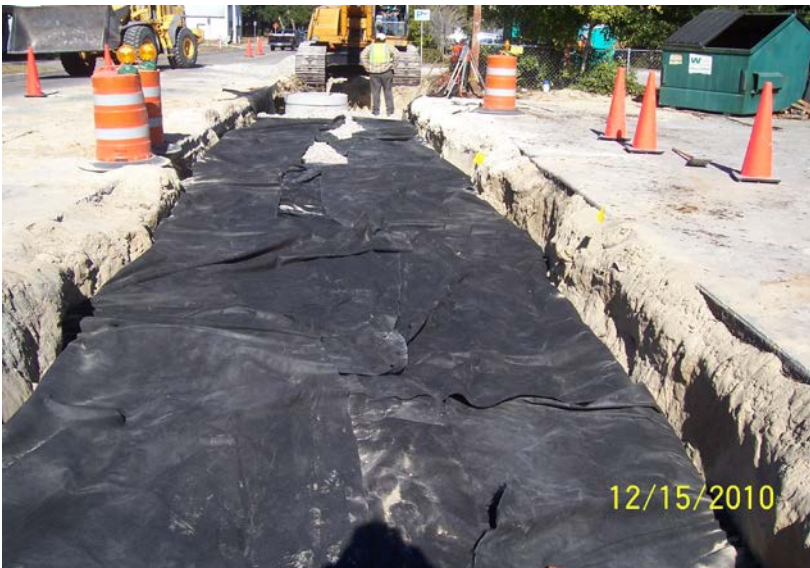
Chambers surrounded with stone and filter fabric

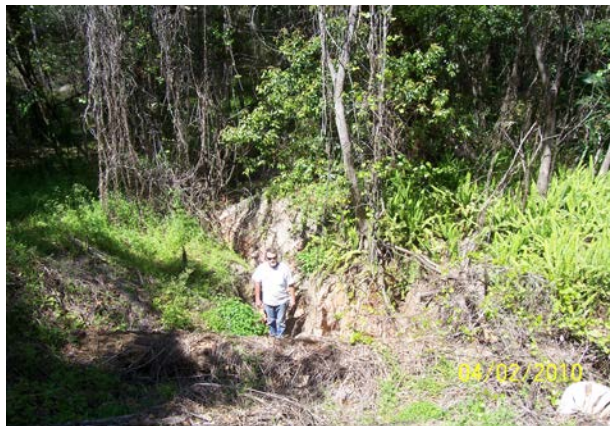
- Stormwater running of the north end of Groveland Road had eroded the hillside and created deep ravines and exposed a large reclaimed water pipeline.
- This area has become the southern portion of the nature park and has been developed for bike trails.
- Structures were installed at the top of the hill and connected to the existing stormwater system.
- A 360-foot long continuous HDPE pipe was laid into a trench down the slope.
- A large deflection structure was installed at the bottom of the hill to disperse the water into the low area within the park.
- The slope was graded and seeded and the bike trails were re-established through the area.

Erosion down hillside before construction

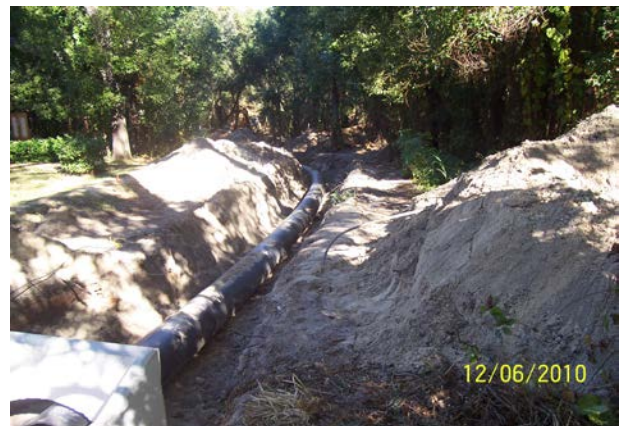
Stormwater pipe installation

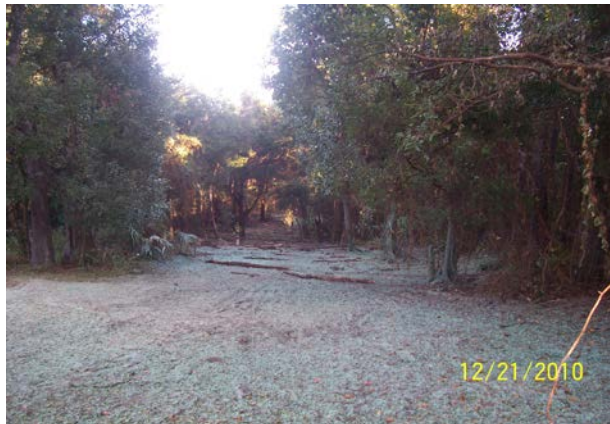
Hillside restored and hydroseeded

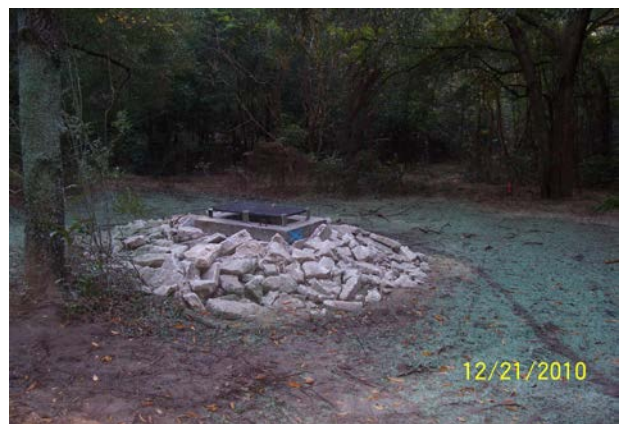
Discharge structure at base of hill

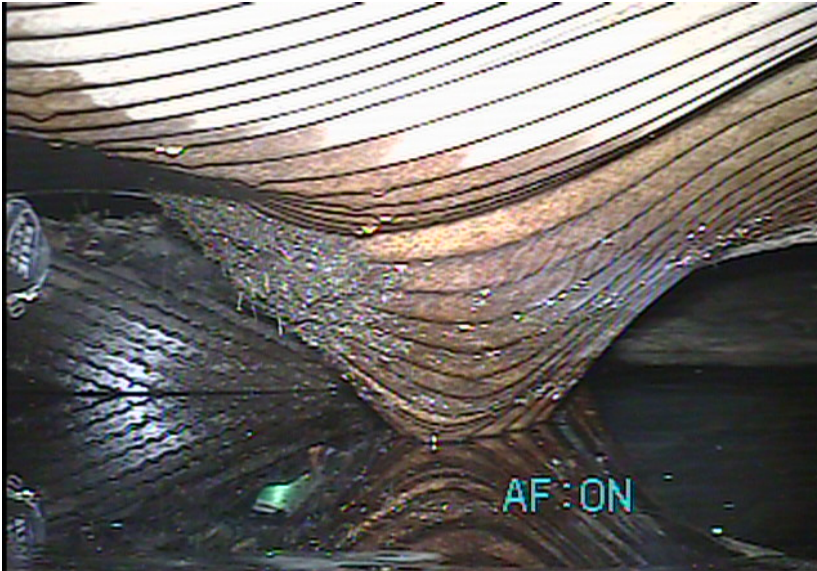
- A 23" x 54" elliptical pipe between Pine Street and Jackson Street has been crushed down to a height of only 8 inches and was further blocked by an old tire.
- This blockage affected the entire northeast section of town by preventing flood waters from being drained away during heavy rains.
- A 20-foot section of pipe was cut out and replaced with galvanized corrugated steel pipe.
- Other blockages were removed from the pipe system further downstream that significantly improved the drainage capacity of the Pine Street system.

View inside crushed pipe between Pine Avenue and Jackson Street

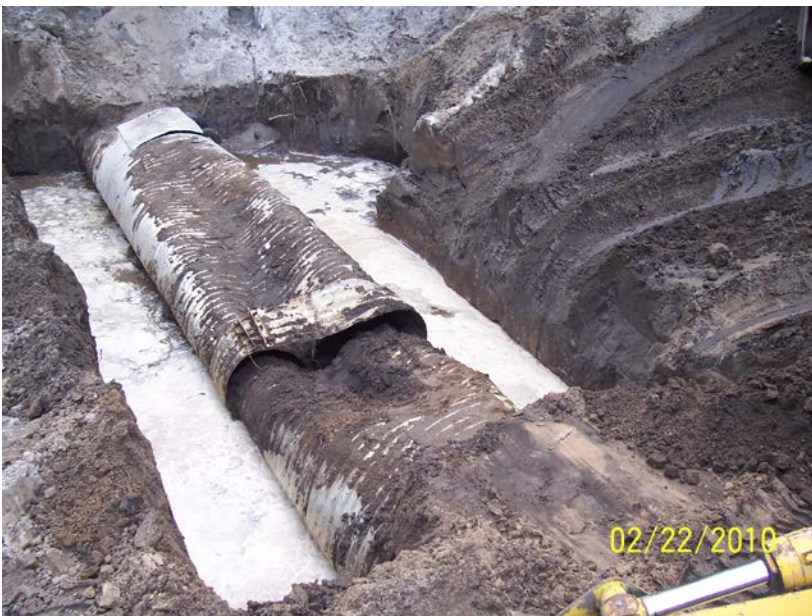
Excavation of crushed section of pipe
